Inspection Report

Mine Name: Lisbon Valley

Operator Name: Lisbon Valley Mining Company

Permit number: M0370088 Inspection Date: January 9,

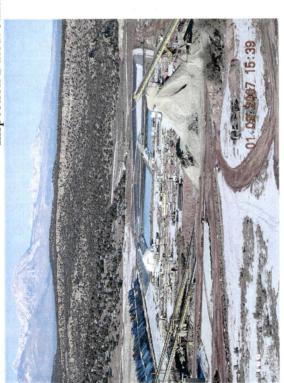
Photo 1. A portion of the processing area with the primary crusher on the right.

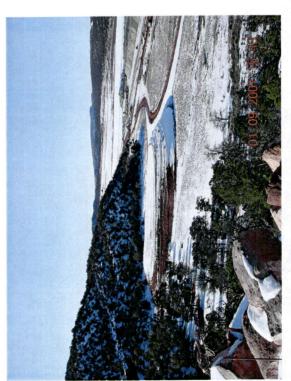
The soil pile near the water tank and to the southwest of the leach pad has been seeded.

Photo 2. The topsoil pile that was seeded.

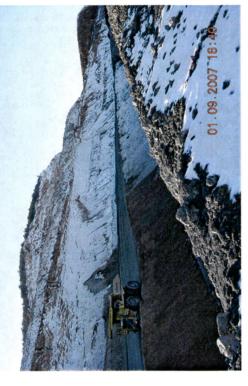
Photo 3. The Centennial Pit.

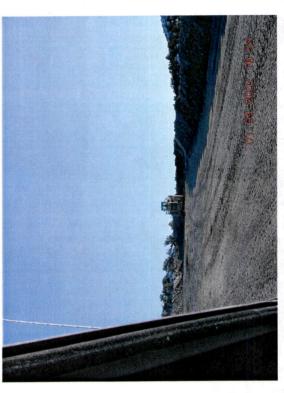
During the inspection, the operator was working to build a road from the Centennial Pit to Waste Dump B using waste material. The area being constructed is over a rocky, pinyon/juniper area where there was probably little soil to salvage, but as the road progresses, the operator should ensure that soil is salvaged where possible.

Photo 4. The beginnings of the haul road to Waste Dump B.

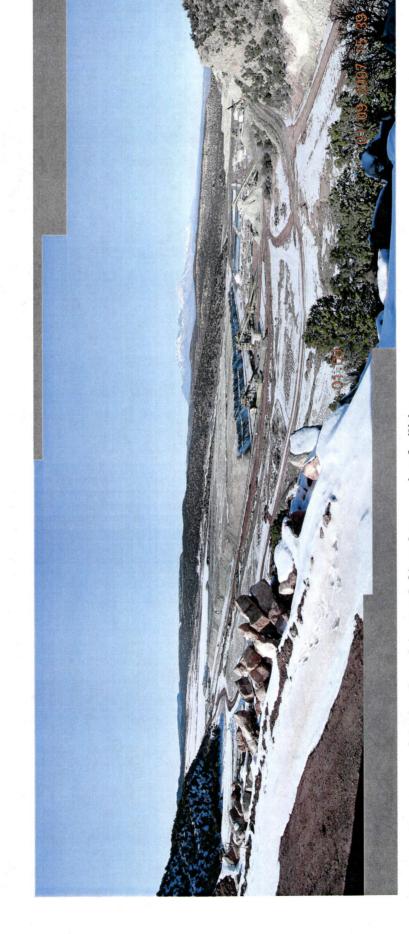
Photo 5. Panorama of the leach pad (center left) and processing facilities.
